**PLANNING ADVISORY COMMITTEE MEETING
AGENDA**

REQUEST FOR DECISION

REPORT TO: Heritage Advisory Committee
SUBMITTED BY: Byung Jun Kang, Planner
DATE: July 25, 2019
SUBJECT: Application to Alter a Municipal Heritage Property – Northwest United Baptist Church at 1609 Big Lots Road, Northwest, NS

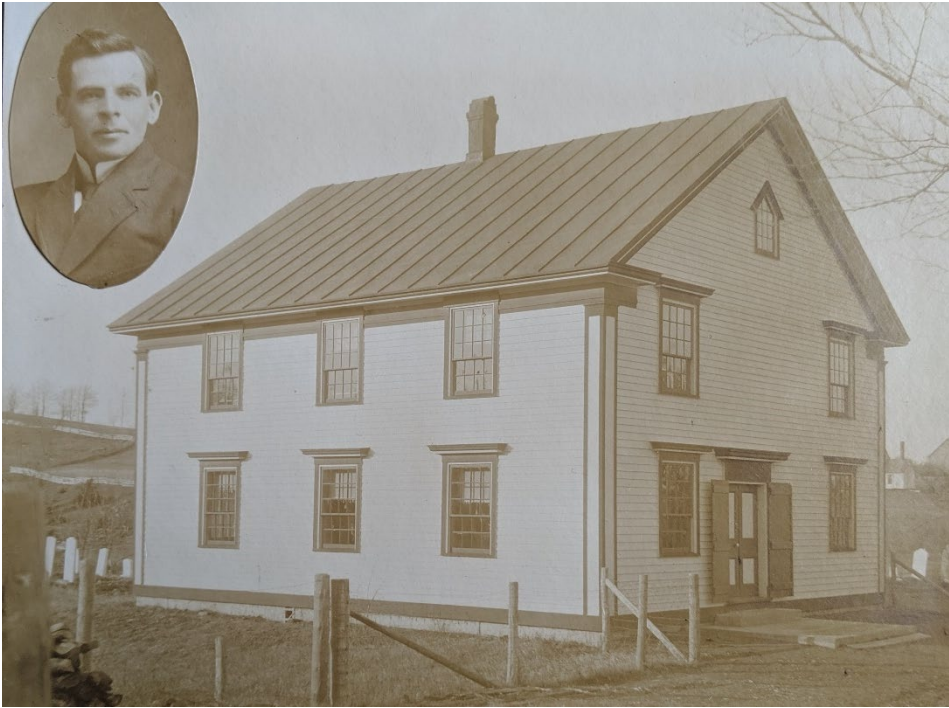
Figure 1. Northwest United Baptist Church (1914). This figure illustrates the church with a metal roof as it was in the 1912-1914 period.

Justification for alteration is that (1) the roof is overdue for replacement, and (2) the older style of the church was a standing seam metal roof and the Trustees would like to revert to that style. The construction is not expected to commence until September 2019, following the approval from Municipal Council.

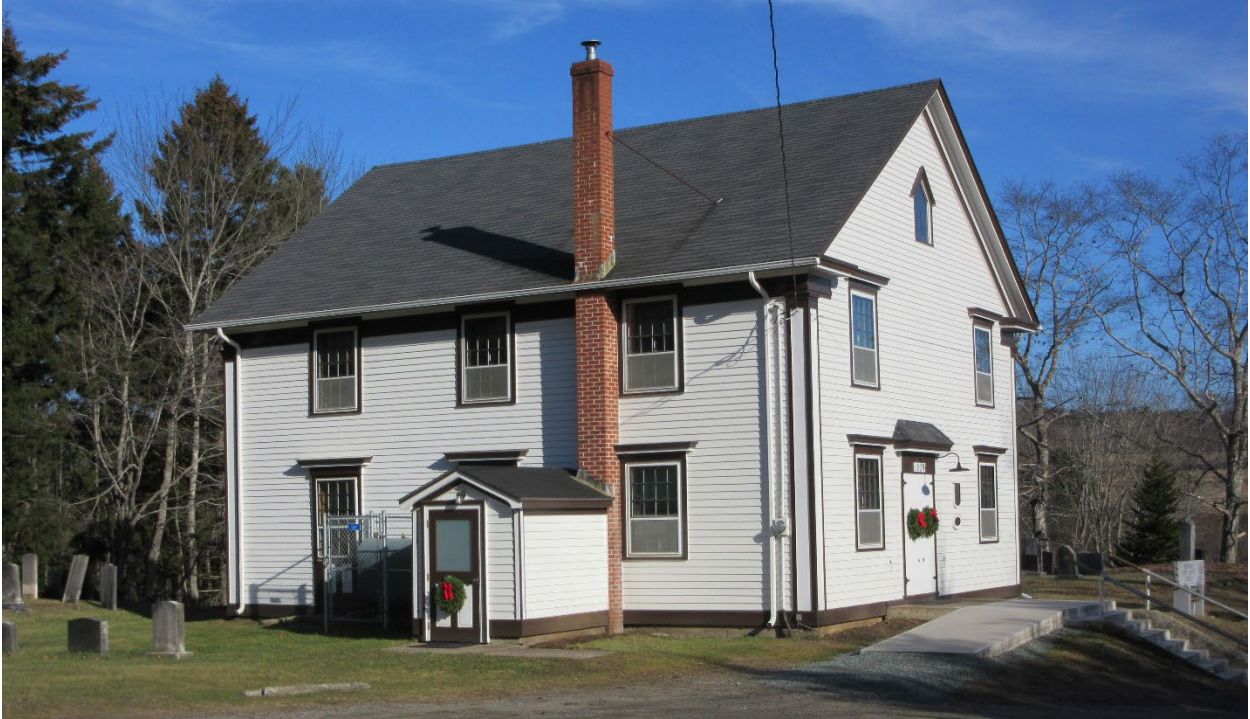
Figure 2. Northwest United Baptist Church (2019). This figure displays the style of the church as it is today, with asphalt shingles.

Staff received a request in June 2019 for an exterior alteration to the Northwest United Baptist Church, a registered municipal heritage property, at 1609 Big Lots Road, Northwest, NS. The request, in Appendix A, is to replace the asphalt roof shingles with dark brown metal roof to match the existing trim on the building. Additionally, the flashing on the rakes and eaves would be a custom width in order to leave the existing wood trim exposed.

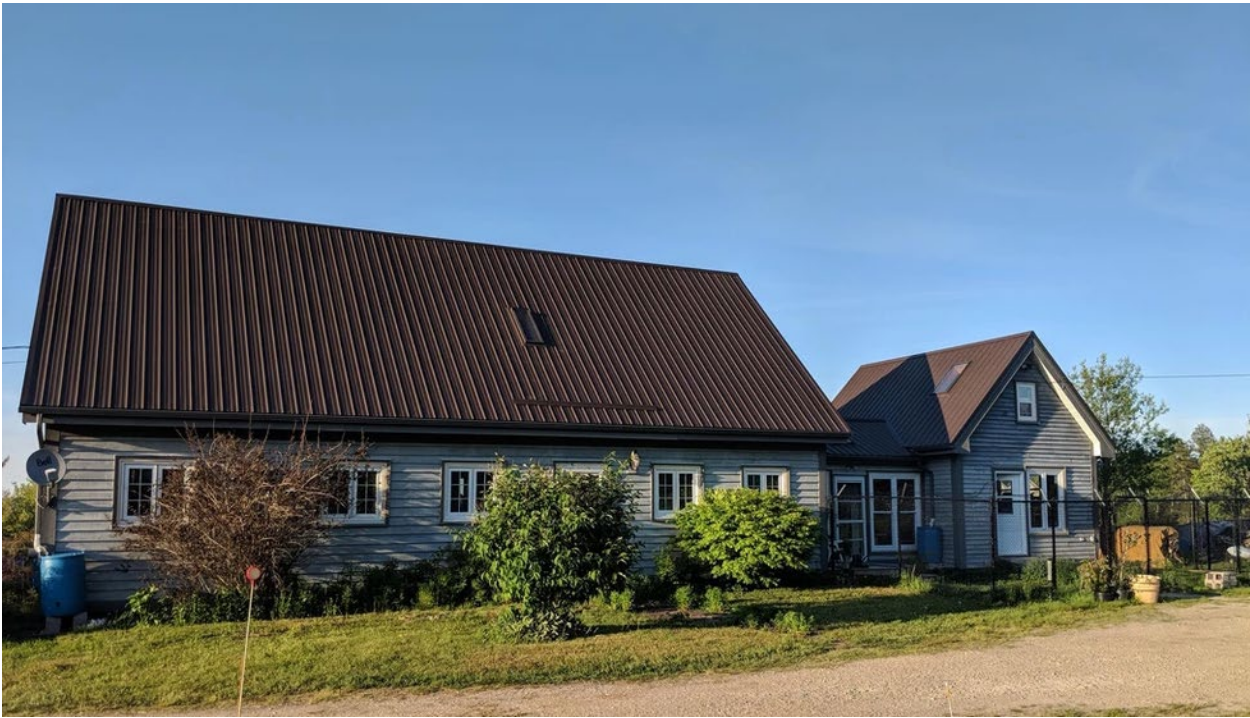
Figure 3. Example of the proposed metal roof style, constructed by Wall's Metal Roofing in Blockhouse, NS.

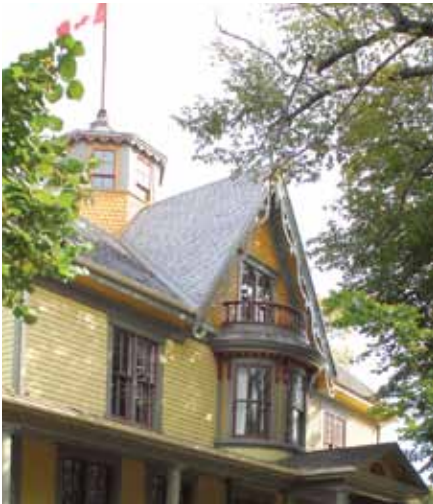
When the windows of Lefurgey House in Summerside, PEI were damaged in a fire, instead of replacing the entire windows, only the broken glass was replaced. The replacement glass, salvaged from a nearby house that was replacing its windows, had similar properties and wavy appearance.

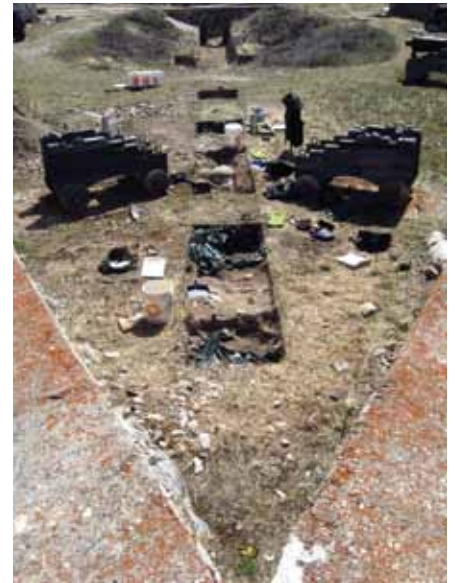
Nearby archaeological resources were protected when stabilizing the Prince of Wales Fort in Manitoba. Strategically placed archaeological investigations on the surface of the ramparts established the extent of artifacts, including their depth below the surface.

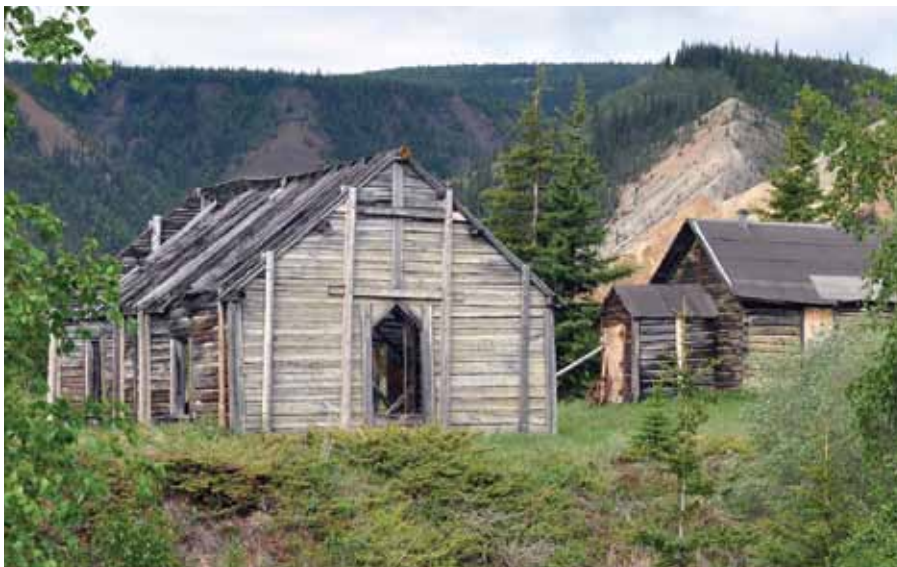
These buildings, along with others at St. Luke's Anglican Rectory and Church in the Yukon, were temporarily stabilized using a variety of measures including adding sandwich bracing, cable bracing, heavy frames, roll roofing, and covering door and window openings in order to keep out snow and rain. Stabilization allows the structures to be adequately researched and their eventual restoration to be planned.

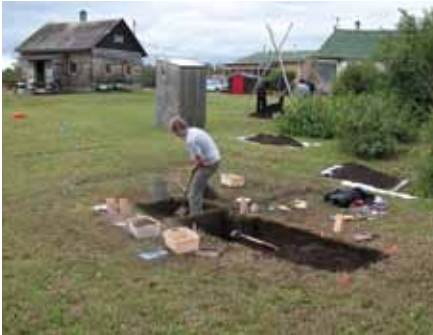
Ground-penetrating radar was used at McPherson House in Fort Simpson, NT; this guided archaeological excavations limiting the impact on the site.

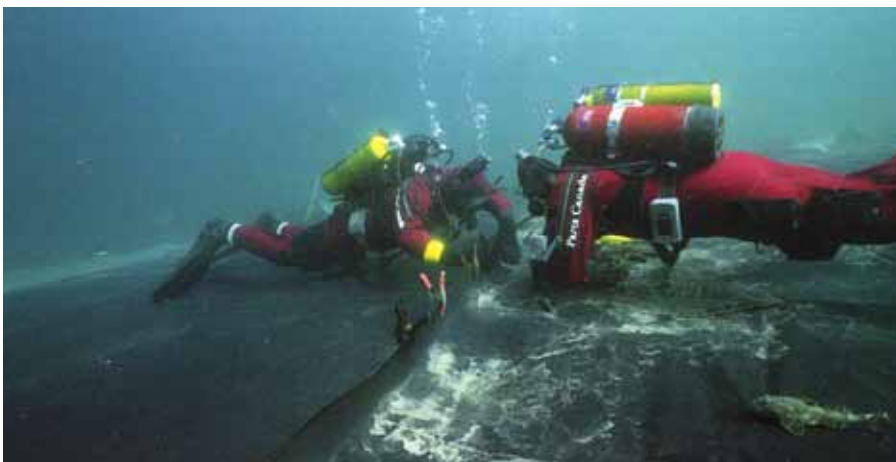
Wrecks at Red Bay NHSC, NL, such as this Basque Period wreck, are reburied using sand and tarp to ensure their long-term preservation. Their condition is periodically assessed through monitoring.

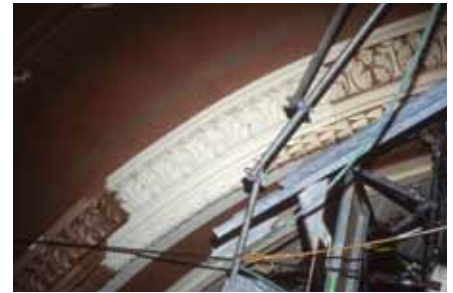
When restoring decorative plaster in the Walker Theatre in Winnipeg, moulds were made of existing plaster elements. The deteriorated plaster was then patched and repaired using the moulds to match the original.

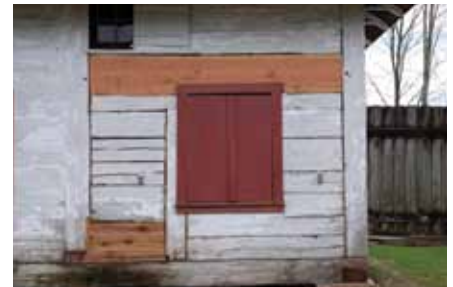
A condition assessment of the exterior walls and frame of this Storehouse at Fort Langley, BC found extensive deterioration of some timbers, which required replacement in kind. The dimensions, hewn finish and species of wood used in the repairs matched those replaced. The photograph shows part of one storehouse wall after the repairs were completed, but before the new timbers were whitewashed.

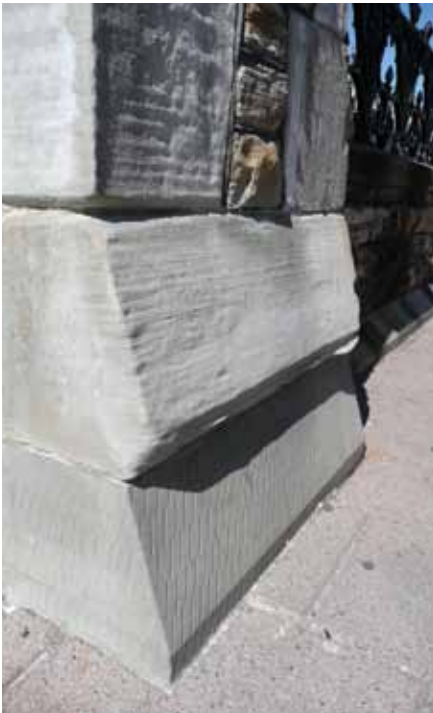
The new pieces of stone on the Wellington Wall at the Parliament Grounds in Ottawa are clearly visible on close inspection due to a different tooling technique.

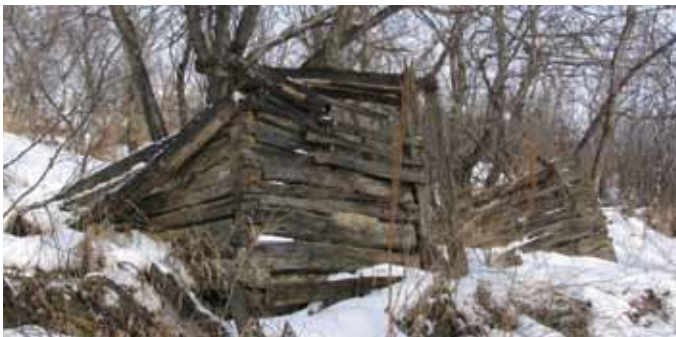
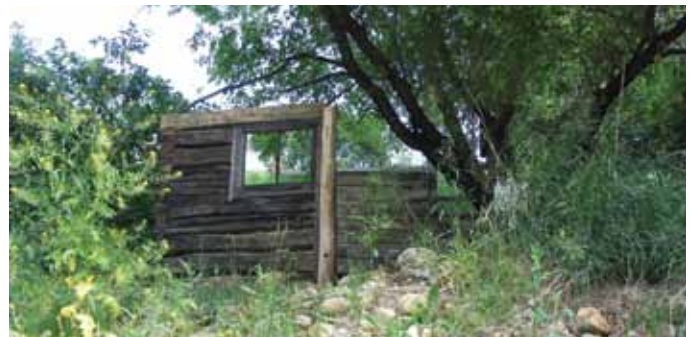
The character-defining elements of Doukhobor Dugout House NHSC in Saskatchewan, such as the window frames, had suffered visible deterioration from exposure to the elements. A long-term repair solution was necessary to prevent further decay and to preserve the site's heritage value.

Following the reinforcement treatment of treating the logs with preservatives, collapsed character-defining elements were reassembled based on records from previous interventions and existing traces on the site.

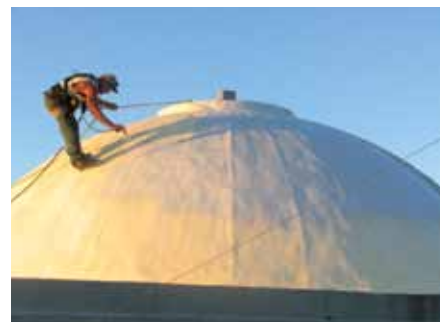
The dome of Melville City Hall was originally an uninsulated, painted-metal covering that caused persistent condensation problems. Applying insulating polyurethane foam with aluminized coating was a cost-effective solution that was compatible with the historic metallic look of the dome. If a more elaborate solution is contemplated in the future, the polyurethane could be removed.
